Name of Dam	Loss Lake
State Located	Missouri
County Located	Dent County
Stream	Tributary To Loss Creek
Date of Inspection	September 26, 1978

LOSS LAKE DAM  
(Formerly No Name 112)

PHASE I INSPECTION REPORT  
NATIONAL DAM SAFETY PROGRAM

PHASE I INSPECTION REPORT  
NATIONAL DAM SAFETY PROGRAM  
LOSS LAKE DAM - ID NO. 30262

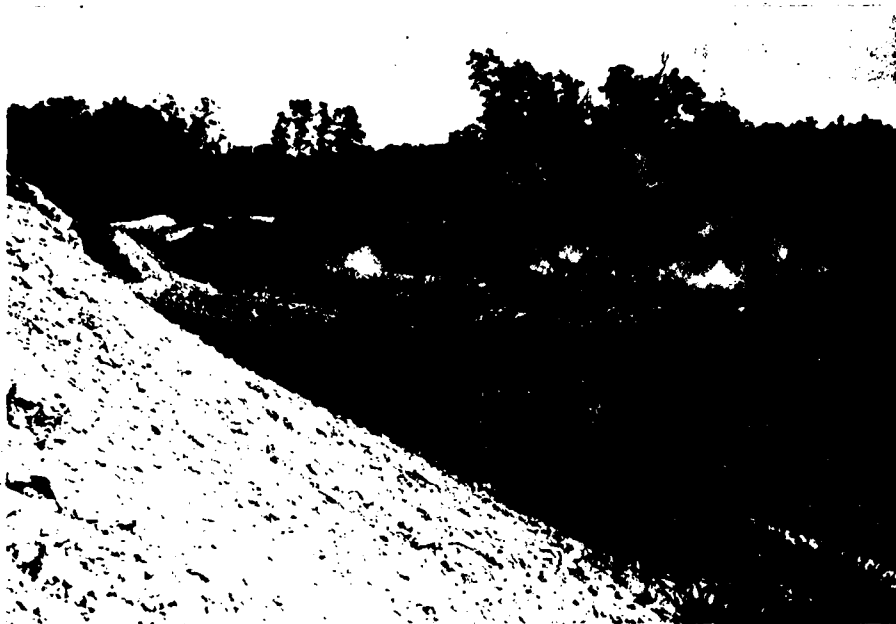
PHOTO 3 View of Spillway Looking Downstream

C. Appurtenant Structures. A spillway is located on the left abutment, cut into residual soil without any erosion protection. A small earth dike was located at the upstream end of the spillway and in line with the crest of the dam. A wire mesh screen is set up in the spillway outlet channel which has created a pool of muddy water with the small earth dike. Spillway discharges may endanger the integrity of the dam.

(4) The spillway and outlet channel should be protected from erosion.
